HUMAN FACTORS ASSESSMENT: M9 ARMORED COMBAT EARTHMOVER (ACE)

April 1988

REPORT DOCUMENTATION PAGE		READ INSTRUCTIONS BEFORE COMPLETING FORM																
1. REPORT NUMBER ARI Research Note 88-12	2. GOVT ACCESSION NO.	3. RECIPIENT'S CATALOG NUMBER																
4. TITLE (and Subtitle) Human Factors Assessment: M9 Armored Combat Earthmover (ACE)		5. TYPE OF REPORT & PERIOD COVERED Final Report February 1983 - December 1985																
7. AUTHOR(s) Gregory S. Krohn		6. PERFORMING ORG. REPORT NUMBER																
9. PERFORMING ORGANIZATION NAME AND ADDRESS Essex Corporation 333 North Fairfax Street Alexandria, VA 22314		8. CONTRACT OR GRANT NUMBER(s) MDA 903-83-C-0033																
11. CONTROLLING OFFICE NAME AND ADDRESS U.S. Army Research Institute for the Behavioral and Social Sciences, 5001 Eisenhower Avenue, Alexandria, VA 22333-5600		10. PROGRAM ELEMENT, PROJECT, TASK AREA & WORK UNIT NUMBERS 2Q263739A793																
14. MONITORING AGENCY NAME & ADDRESS (if different from Controlling Office) - -		12. REPORT DATE April 1988																
		13. NUMBER OF PAGES 185																
		15. SECURITY CLASS. (of this report) Unclassified																
		15a. DECLASSIF

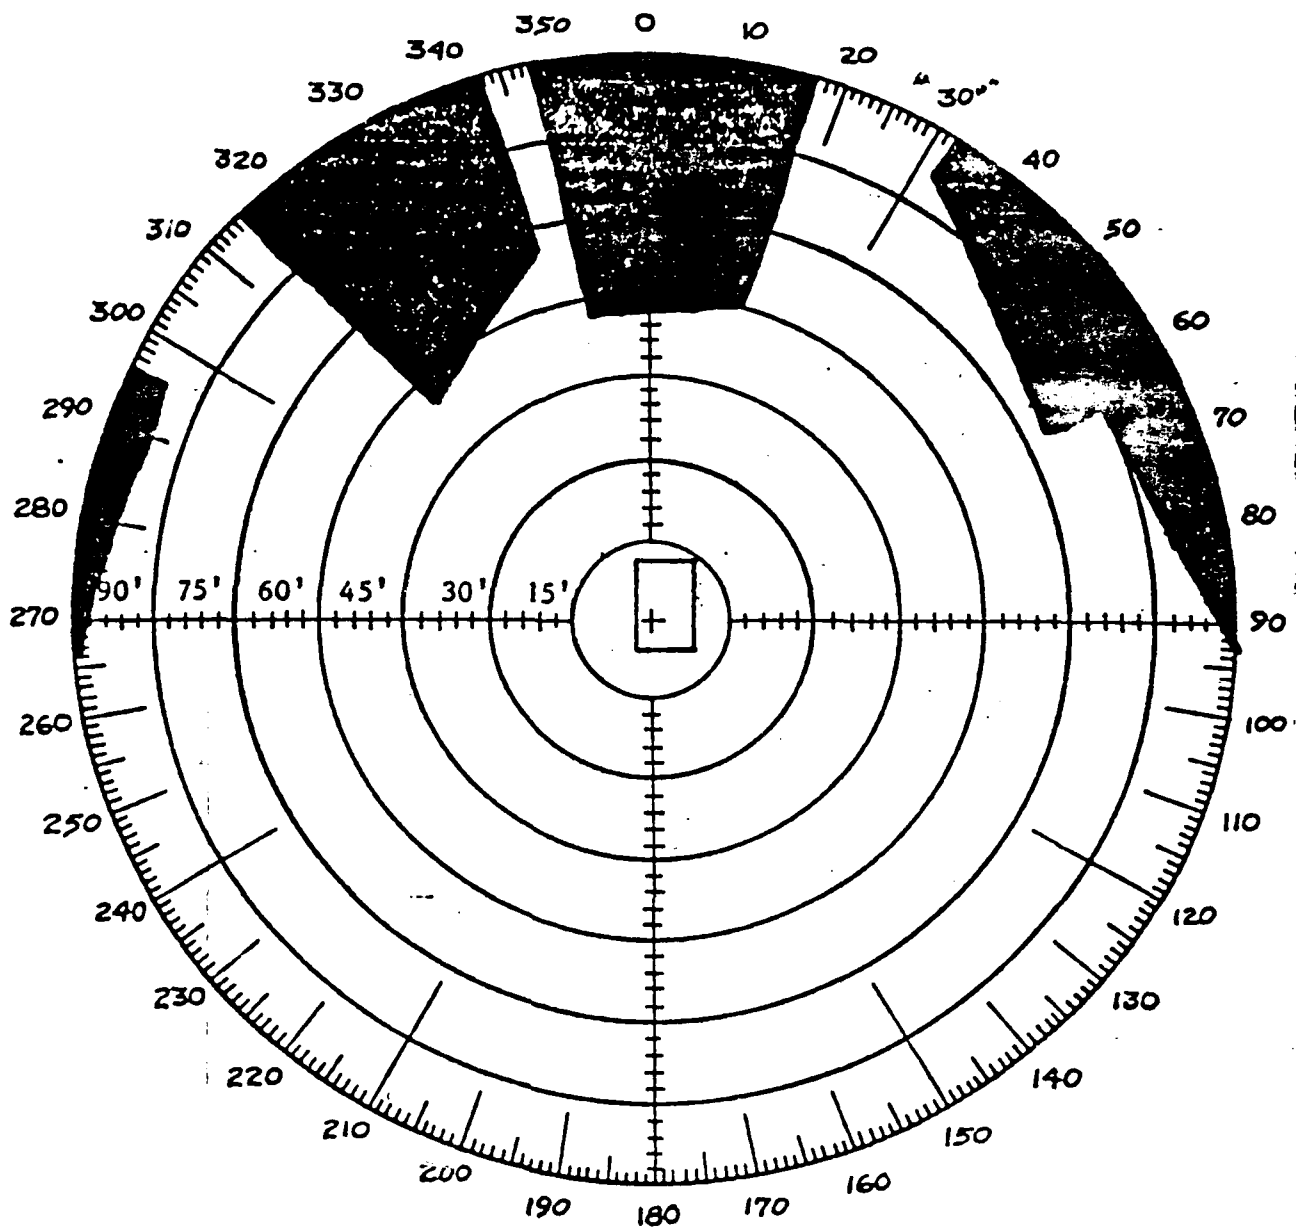
TEST ITEM: M9 ACE		DATE: July 2, 1984
STATION: Operator		TESTER: Beran, Ekquist
TOTAL UNOBSTRUCTED VIEW: THROUGH VISION BLOCKS 157°		MINIMUM DISTANCE @ 0° 56 feet
REMARKS: HATCH CLOSED

Figure 14. Blade in travel position, hatch closed; 5th and 95th percentile operators, measured at the same eye height.

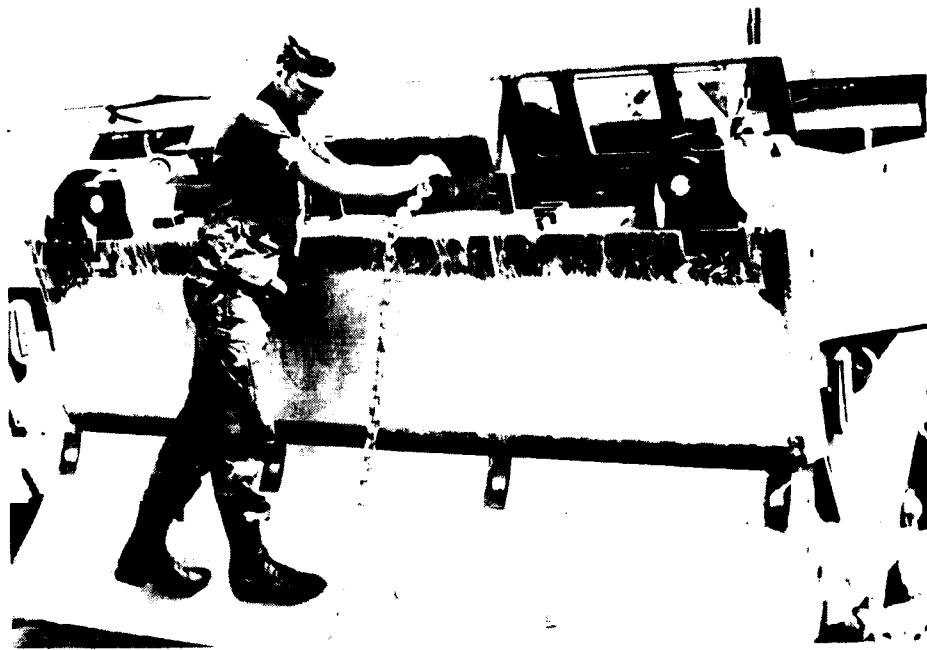
Figure 37. An operator attaching the chain to the ejector blade and positioning it down the center of the dozer blade. (NOTE: The chain passes through the stowage area above the dozer blade.)

An alternative to the procedures involves raising the apron and dozer blade allowing the operator to stand beneath the dozer blade to attach the chain. However, the additional steps add approximately 15 minutes to the 20 to 30 minutes procedure. The additional time results from removing and replacing the apron pins (see Deficiency: Apron and Dozer Blade Lock Pins, pg 64). Moreover, unless the apron is fully raised and locked with its safety pins (making the shackle difficult to reach) the dozer blade and apron could fall on the operator, again as a result of pressure changes in the hydraulic system.

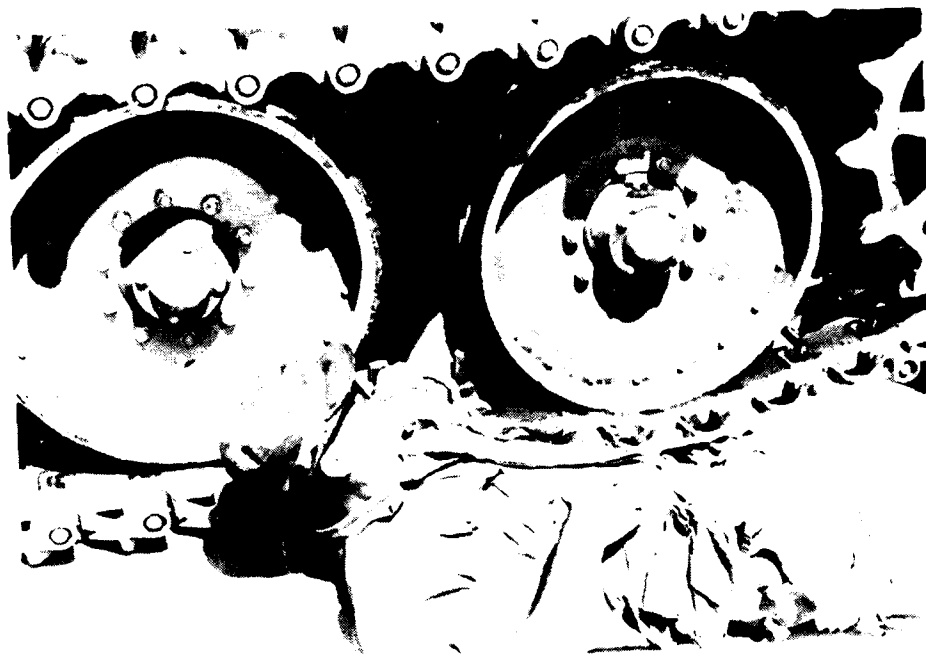
Description of the Safety Hazard: Figure 53 shows a mechanic reaching into the roadwheels in order to hold a dog bone jack in place between the upper and lower portions of the track. Figure 54 shows the dog bone jack.

Figure 53. A mechanic reaching between the roadwheels to position the dog bone jack.

1. Use the hydraulic jack only on hard paved surfaces.
2. Modify the dog bone jack to make it self-standing during positioning of the vehicle. This might be done by adding a hinged bipod to one side of the jack. The bipod would angle outward from the jack and wedge into the ground, creating a tripod of the jack.
